Northern Illinois Utilities, Inc.  
McHenry County - 111-5850

ATTACHMENT "A"  
VIOLATIONS, DEFICIENCIES AND RECOMMENDATIONS

Bureau of Water - Division of Public Water Supplies  
Inspection Report - Elgin Regional Office

FACILITY NAME	Highland Shores Water Company		FACILITY NUMBER	111-5300		
PLANT PHONE	1-815-653-2961		COUNTY	McHenry		
INSPECTION DATE	May 30, 2000		INSPECTED BY:	Chris Johnston and Manny Abad		
SEND CORRESPONDENCE TO			EXEMPTION / LABORATORY FEE STATUS			
NAME OR ENTITY	Mr. Thomas P. Mathews		CHLORINE (Date)	Not exempt.		
ADDRESS	7314 Hancock Drive P.O. Box 189		CERTIFIED OPERATOR (Date)	Not exempt.		
CITY, STATE, ZIP	Wonder Lake, IL 60097		LAB FEE PARTICIPANT (Y/N)	No.		
CONTACT INFORMATION						
CERTIFIED OPERATOR	Mr. Thomas P. Mathews		CLASS	"C"	NUMBER 00956	
PHONE	1-815-653-2961		FAX	1-815-653-2081		
PORTABLE PHONE	1-815-482-1401		OTHER	Home: 1-815-653-7171		
OWNER - RESPONSIBLE PERSONNEL	Mr. Thomas P. Mathews		TITLE OR POSITION	Owner		
PHONE	1-815-653-2961		FAX	1-815-653-2081		
OTHER CONTACTS	NAME		TITLE OR POSITION		PHONE	
	Mr. Jeff Claus		Vice President		1-815-653-2961	
	Mrs. Evelyn Raske		Office Manager		1-815-653-2961

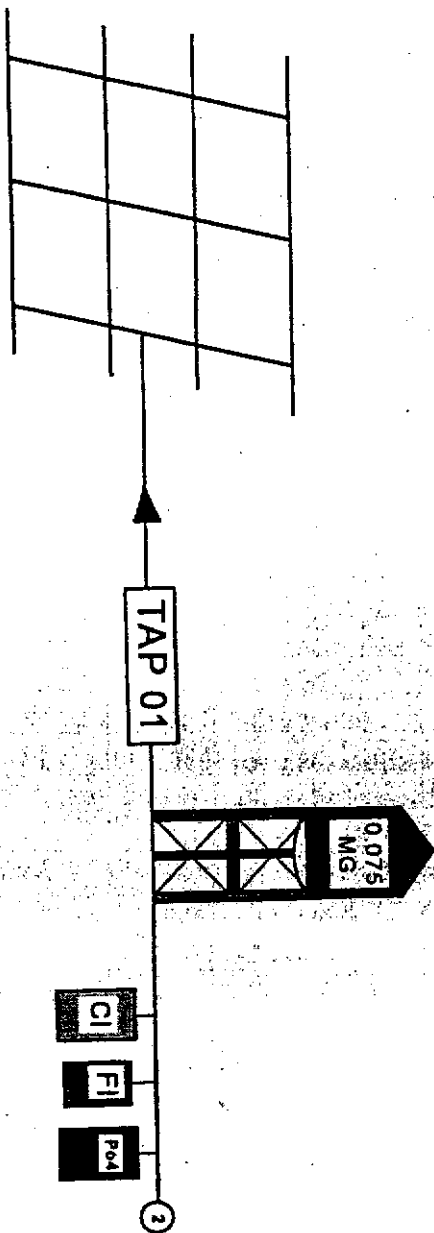
Well #2  
ID 20148  
Status: Active  
Capacity: 110 gpm  
Aquifer: Sand & Gravel
